DEVELOPMENT OF CLINICALLY RELEVANT TESTING METHODS FOR THE FATIGUE PERFORMANCE OF TIBIAL TRAYS

**SUBMITTED FOR THE DEGREE OF DOCTOR OF PHILOSOPHY
DEPARTMENT OF MECHANICAL ENGINEERING
UNIVERSITY OF LONDON**

FEBRUARY 2004

**THE CENTRE FOR BIOMEDICAL ENGINEERING
INSTITUTE OF ORTHOPAEDICS AND MUSCULO-SKELETAL RESEARCH
UNIVERSITY COLLEGE LONDON
ROYAL NATIONAL ORTHOPAEDIC HOSPITAL TRUST
STANMORE
MIDDLESEX
UNITED KINGDOM**

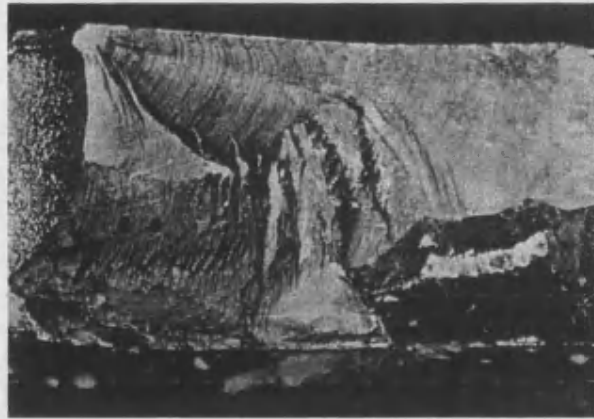
(a)

Figure 3.9: Characteristics of stage two crack propagation.

Macroscopically crack propagation in Stage II shows characteristic propagation patterns. These are indicated by the beach marks (figure 3.9) on the fatigue fracture surface and also by the crack front at the transition to final catastrophic fracture. The beach marks lying parallel to the fatigue striations form due to changes in loading and/or due to changes in the crack tip environment and the surface layers that subsequently form.

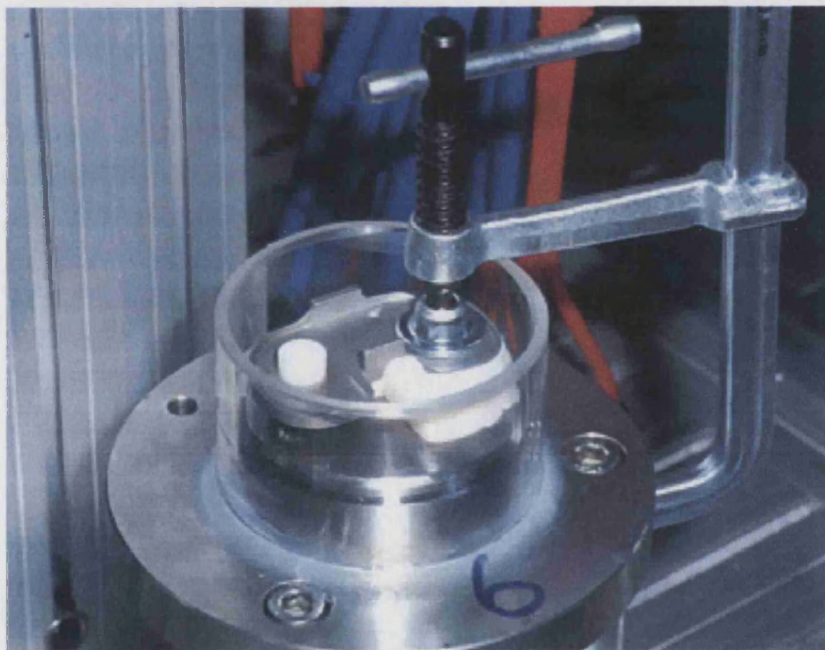
(b)

Figure 4.4.3(a &b): Mechanical test set-up.

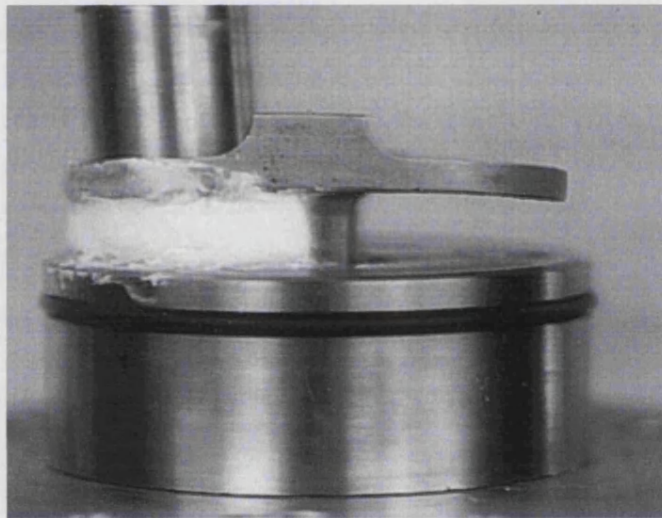
Figure 4.4.5: Maximum principal stress distribution for the hexahedral model of the Kinematic tray for (a) the first contact position, (b) the second contact position. (inset : detailed views of stresses in the gap) (c) deformed Kinematic component after being statically loaded.

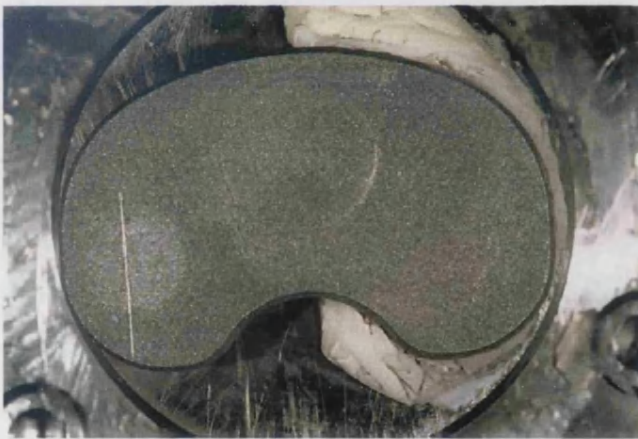
(g) main & inset: Crack formation on third baseplate at 1,716,220 cycles

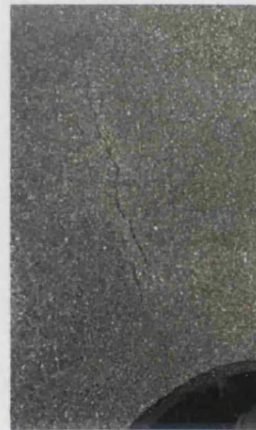
Figure 4.5.8(cont'd): Fractured baseplates of the AGC.

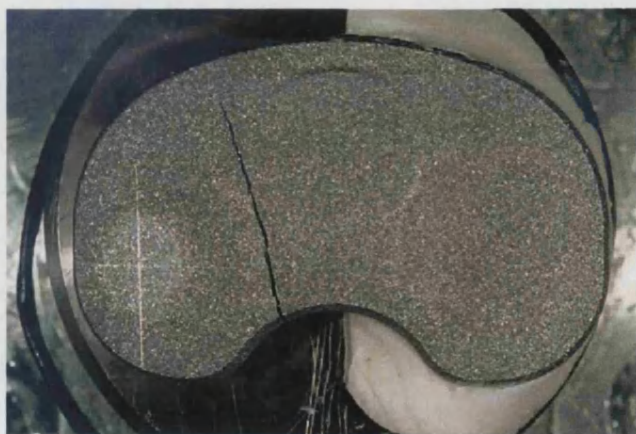
(h) Fracture of fourth baseplate at 3,133,190 cycles.

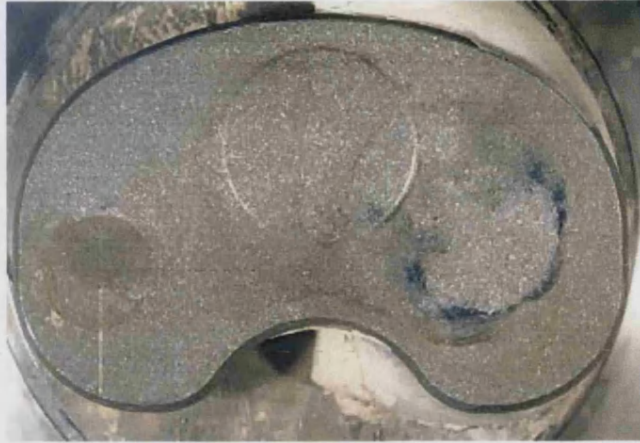
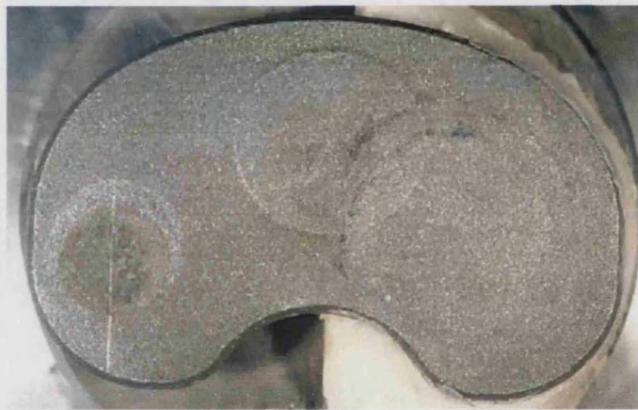
Figure 4.5.8 (cont'd) (i & j): No crack formation at 5 million cycles for the fifth and sixth baseplates using a load level of 2000N.

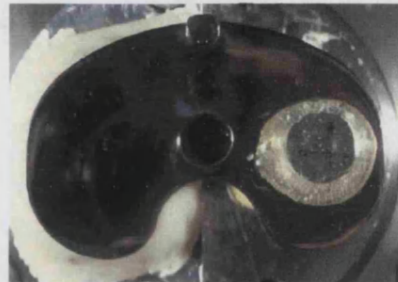
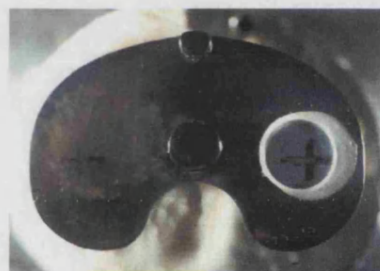
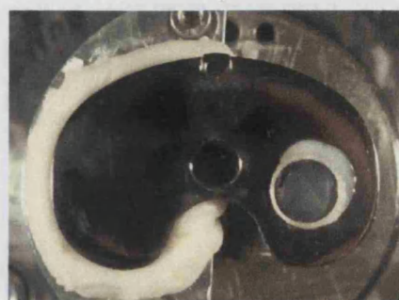
Figure 4.5.16 (a-b) FEA models show that the peak stress for the Rotaglide model at 900N is 260 MPa. This is below the fatigue limit for cast CoCrMo alloy. Upper and lower surfaces of the Rotaglide trays showing survival of (c & d) uncoated (e & f) porous coated (g & h) HA-coated at 5 million cycles.

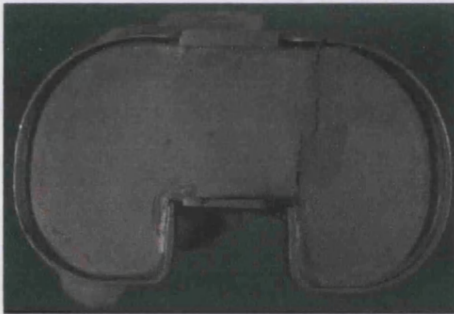
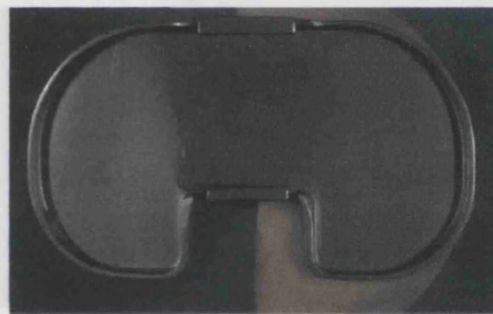
Figure 4.5.18 (a-b) FEA models show that the peak stress for the Kinematic model at 900N is 2.05GPa. This is significantly higher than the fatigue limit for cast CoCrMo alloy. (c & d) Failure of both Kinematic trays occurred at 154,300 and 485,700 cycles.

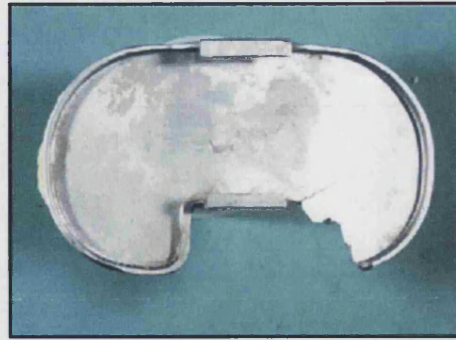
Figure 6.2.1 (e) Retrieved tray, showing crack formation in the posteromedial part of the tray, consistent with figure 6.2.1 (d)

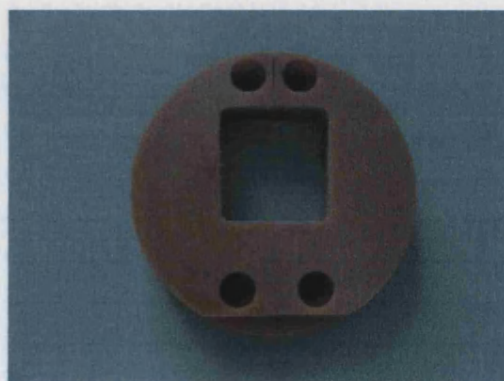
Figure 6.3.3: Support blocks made from (a) titanium (b) aluminium (c) Delrin (d) polyurethane.

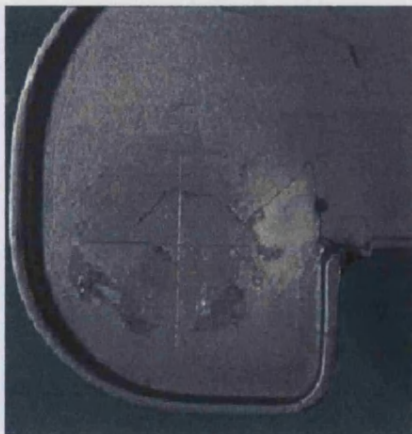
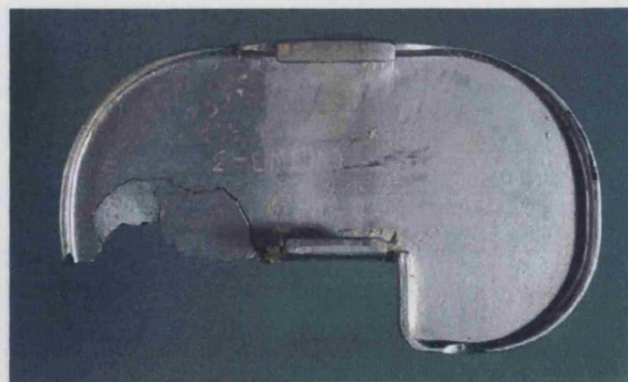
Figure 6.3.8: (a & b) FEA results of the Kinematic component supported on a partial aluminum support. (c) Aluminum partial support block. (d) Fatigue test result of the Kinematic component using support block in (c). (e) Kinematic retrieval.

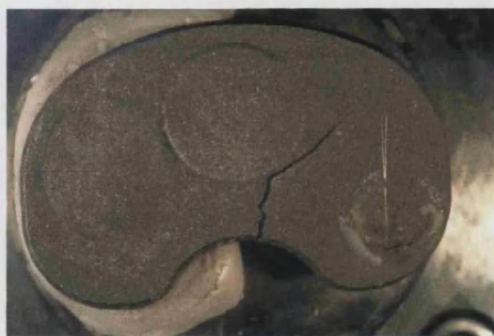
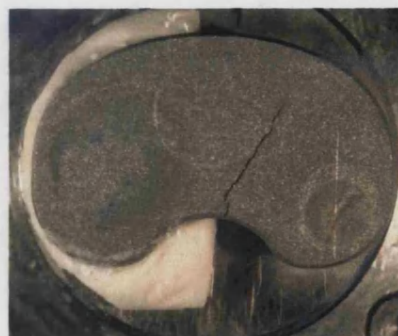
Figure B2.2 (a & b): FEA results of the AGC (c & d) Mechanical test results showing failure at 2000N for two samples.

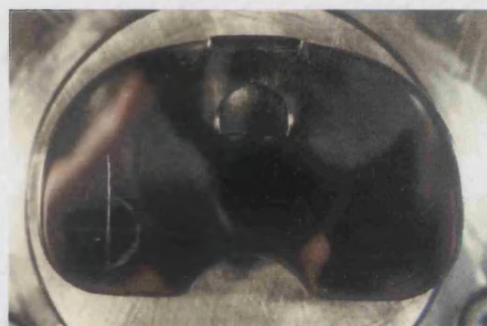
(d)

Figure B2.3: (a & b) FEA results of the Kinematic (c & d) Mechanical test results showing survival at 1400N for two samples to five million cycles.

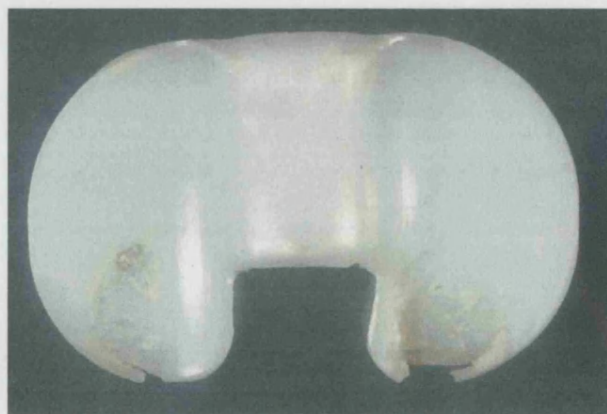
Figure C1.3: COMPONENT E: Failure of a Kinematic knee in one of the compartments as a result of polyethylene wear and malalignment. Fractured tibial tray (a) top view (b) from below (c) tibial baseplate (d) fractured portion showing shiny surface (e) tibial insert with wear more marked in same location as fracture of the baseplate.

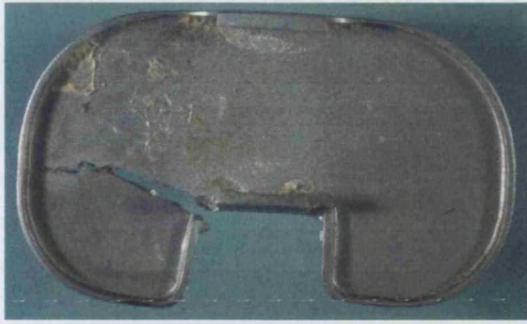
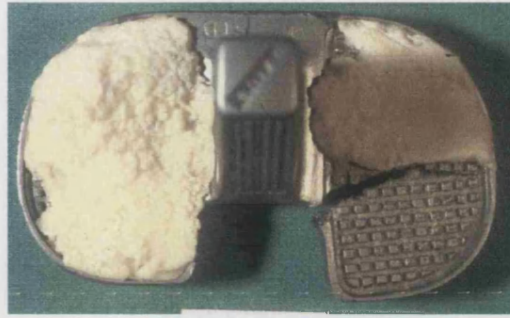
Figure C1.4 (a & b): COMPONENT F: Medial compartment fracture of a Kinematic tibial tray of a right knee in a patient two years post-operatively.

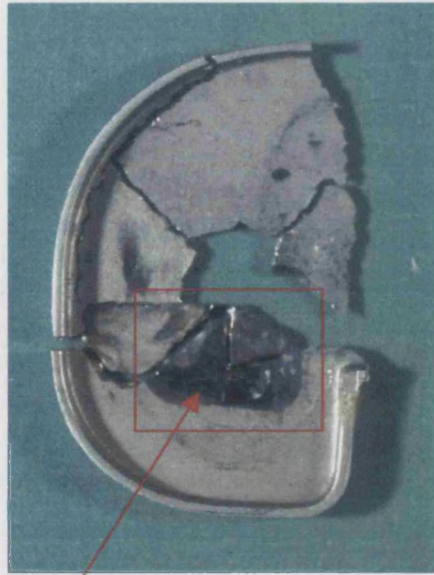
Shiny surface on upper part of fractured portion of tray

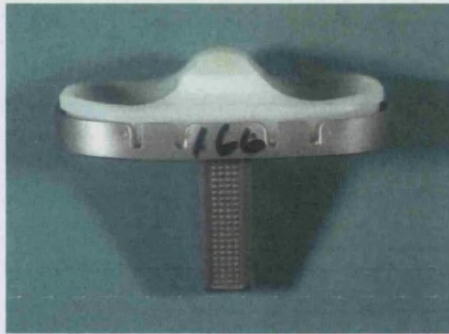
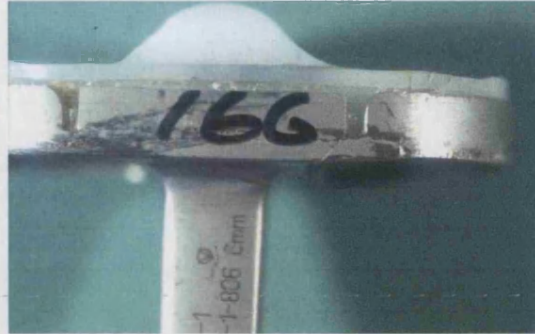
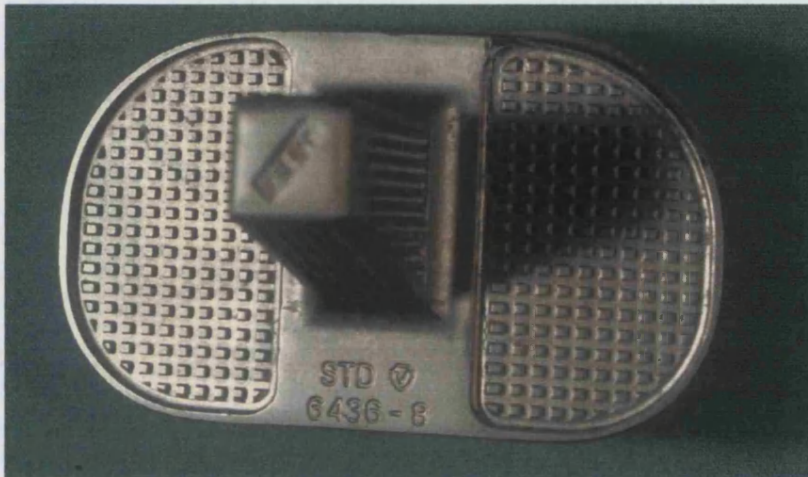
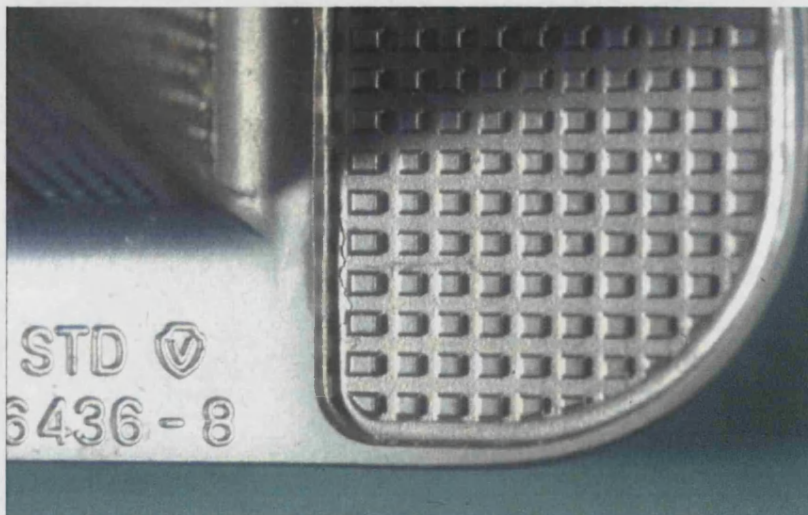
Figure C2.2: COMPONENT N(a-d): Fracture of a Total Condylar design.
The fracture began at the anterior side at one of the grooves within the design. The tray was removed prior to the fracture reaching the other side of the tray.
